Manhole Inspection Summary

Manhole # S33WW_008MH

Insp Date: **6/30/07 11:33 AM**

Location Address: **3100 CHARLES ST**

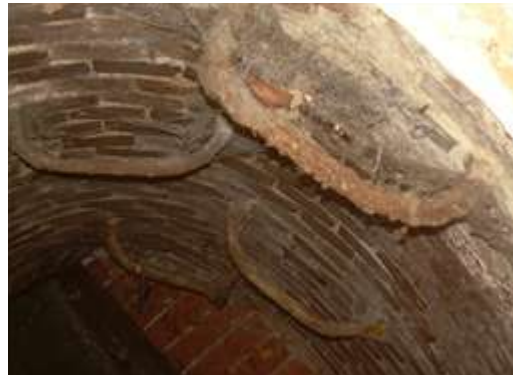
Location View

Corroded steps.

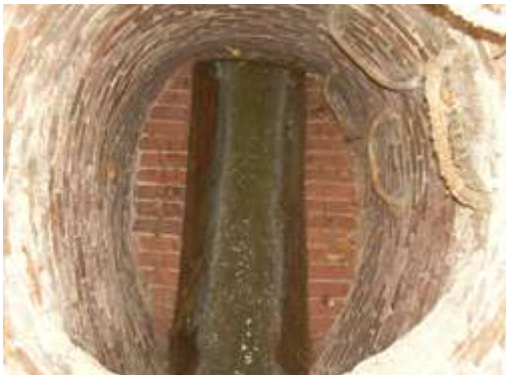
Top View

Corroded steps. Evidence of surcharge - Bench debris.

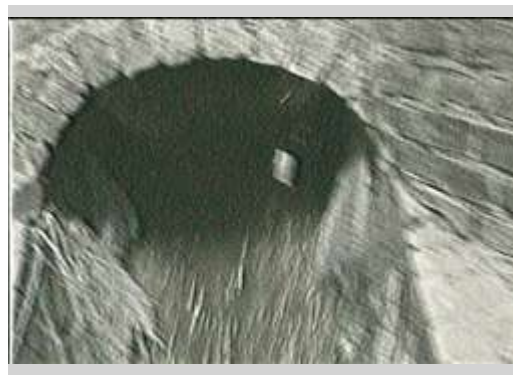
Defect

Channel root intrusion.

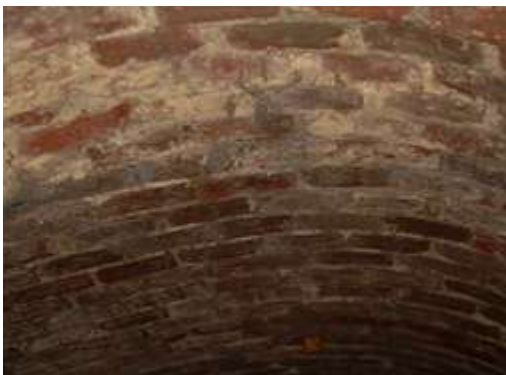
Defect

Corbel infiltration.
